# **APPLIED ULTRASONICS**

### ULTRASONIC IMPACT TECHNOLOGY (UIT)

Case Study Examples

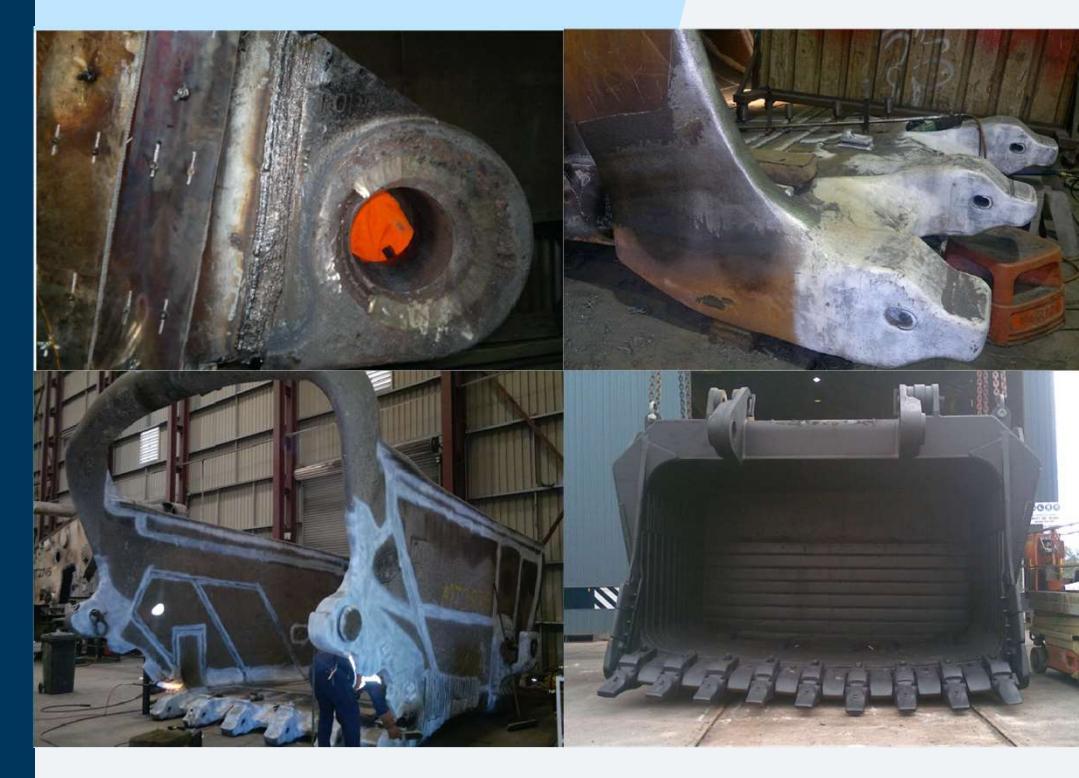
### **DIPPER & DRAGLINE BUCKETS**

- Crack repairs
- Linkage repair/replacement
- Teeth
- Adapters
- Distortion control

In the majority of these examples the cracks were being treated every refurb cycle and were the key reason for the bucket needing to be changed out. By using UIT during the repair process, fatigue life improvements enabled the site to extend the bucket changeout cycle by 9 weeks and deliver and additional 3.6M BCM before changeout.

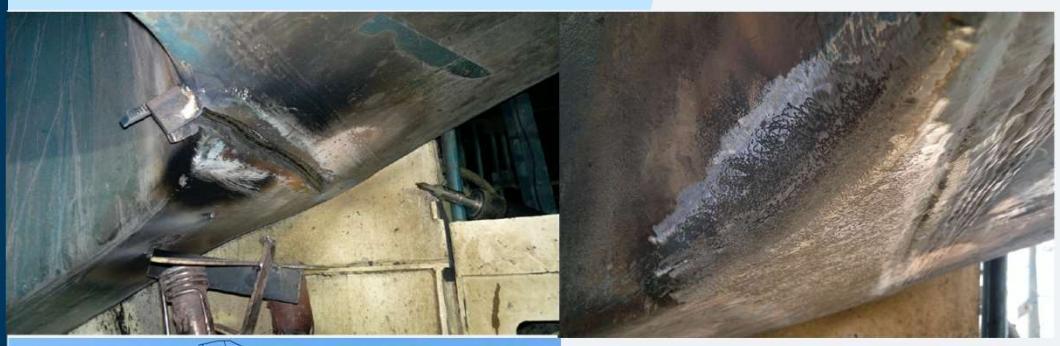
### EXCAVATOR BOOM FIELD REPAIR

- Boom crack repaired in the field minimizing downtime
- UIT was used to treat critical structural welds

The use of UIT being a mobile machine allowed for a field repair to be undertaken driving significant cost and time savings due to not needing to remove the boom. 20,000hrs post repair and still no signs fatigue or cracking.

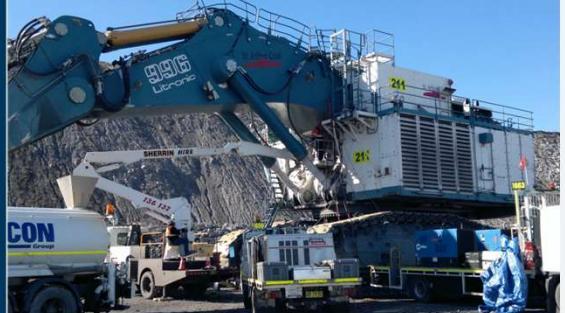
Dipper Handle Pyramid

- Large (6ft) crack located in Pyramid area of Dipper Handle casting, requiring repair leading to downtime every 3 weeks to repair crack
- UIT used to treat each weld layer
- UIT repair lasted 26 weeks until the replacement part was available
- 8 x life extension
- Was treated on the machine

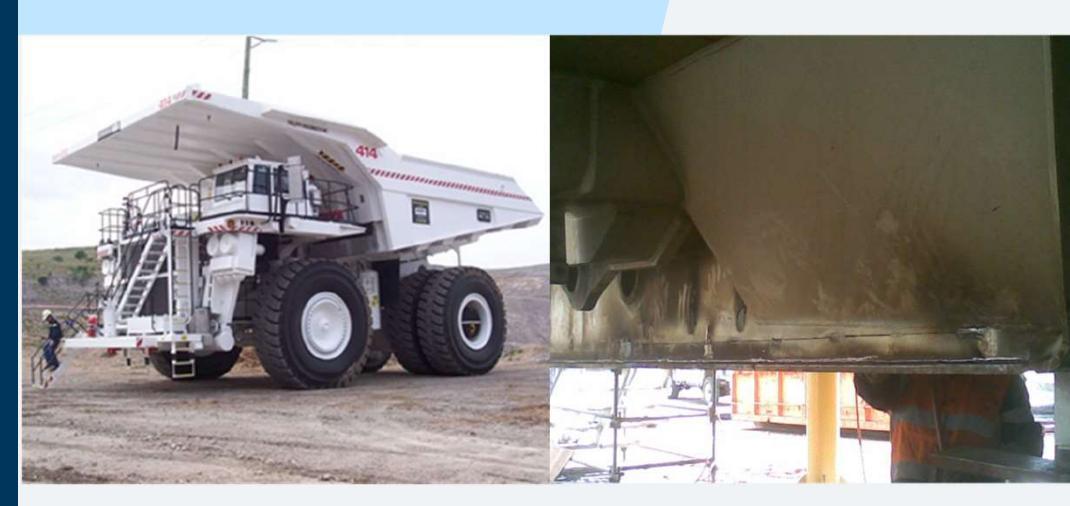
### DUMP TRUCK BEDS

- Truck body frame rail welds consistently cracking
- Welds excavated, replaced and UIT used to treat new welds
- Cracks never reappeared

UIT was treat truck trays that had significant cracking evident in the front chassis section. Post repair 35,000hrs later still no cracking or structural issues noted.

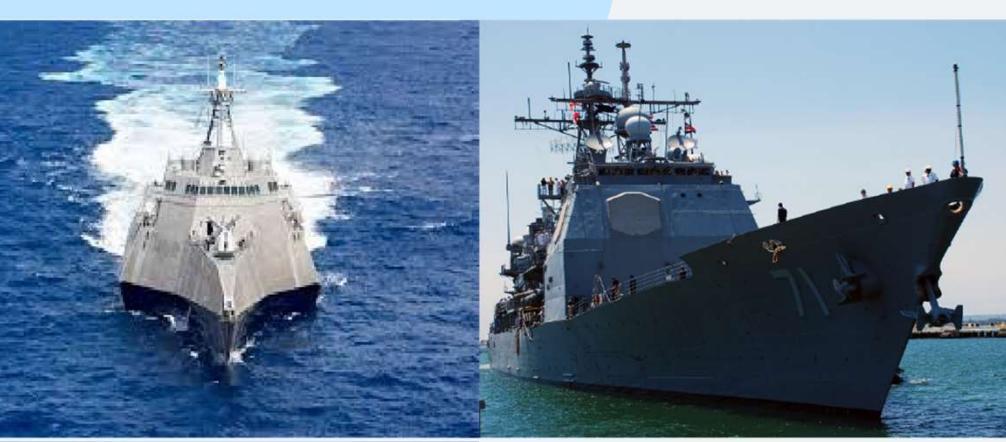
### **US Navy**

- Stress Corrosion Cracking (SCC) present in ship support structures,
- Standard weld repairs were failing prematurely and weld repairs ultimately resulting in additional cracking
- UIT was implemented pre/during/post welding on USS Cape St. George as the trial
- Result was zero cracks present on USS Cape St. George, (5 years later).
- Post trial UIT was performed on 20+ CG class ships and zero cracking present in UIT treated areas (5 years + since treatment)
- US Navy expanded UIT use to LCS and EPF class ships
- Cost avoidance in \$100M+
